Cloich Forest Wind Farm

Volume 3 – SEI Report Technical Appendices (Part 1 of 2)

A9.1 Peat Slide Risk Assessment

TECHNICAL APPENDIX A9.1: PEAT SLIDE RISK ASSESSMENT

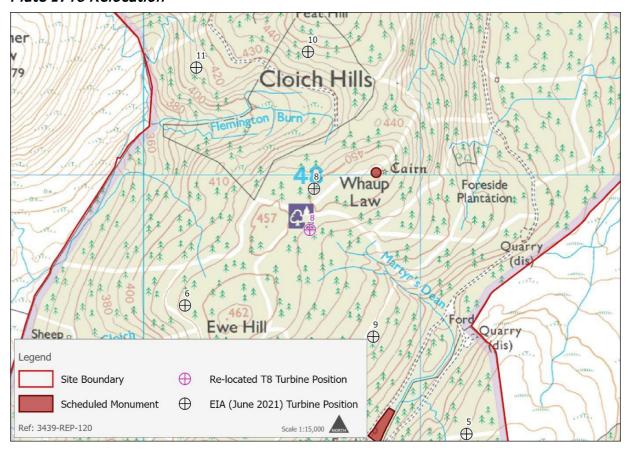
Plate 1: T8 Relocation

The alternative location for T8 represents a \sim 150 m southward move from its original location; the movement takes T8 down 10 m Above Ordnance Datum (AOD) from 450 m AOD to 440 m AOD, and off of the crest of the hill on which SM2755 lies. Further movement south is constrained by a deposit of deep peat (currently avoided), as well as other environmental/technical considerations including:

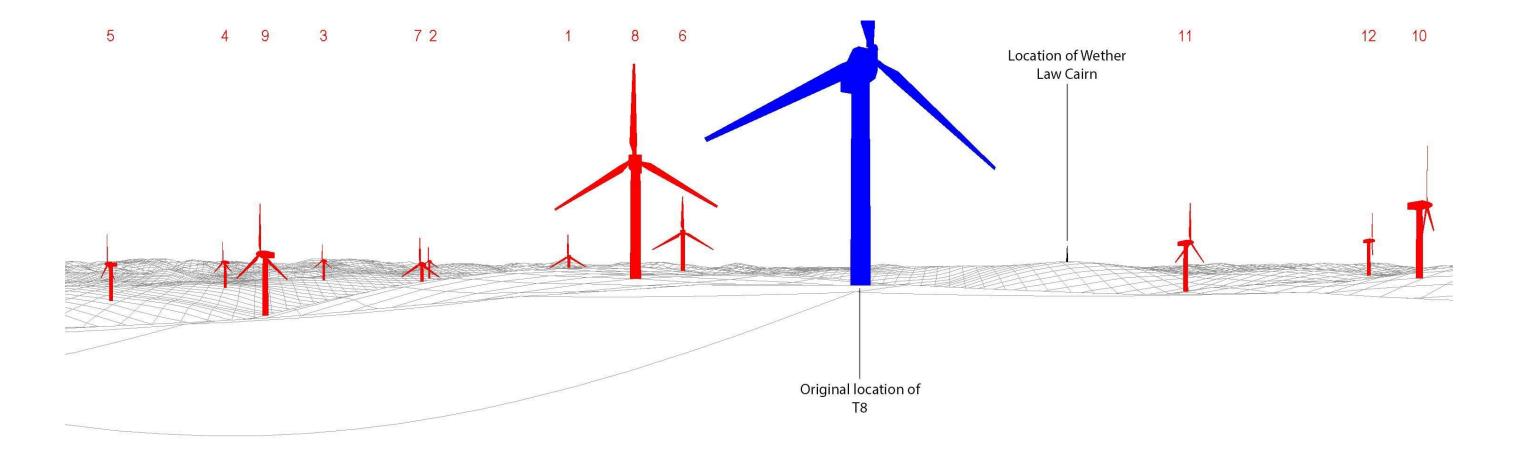
SM2755 Whaup Law Cairn

Appendix A Figure A1: SM2755 Whaup Law Cairn T8 Comparison (180 degree field of view)

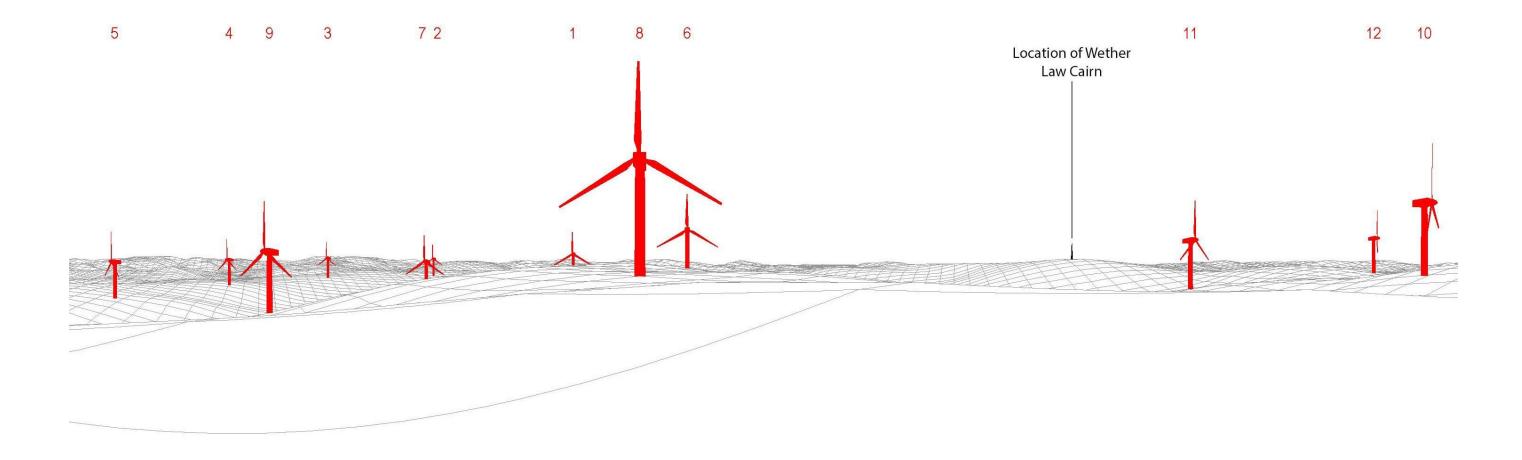
SM2755 Whaup Law Cairn

Figure A2: SM2755 Whaup Law Cairn T8 Relocation (180 degree field of view)

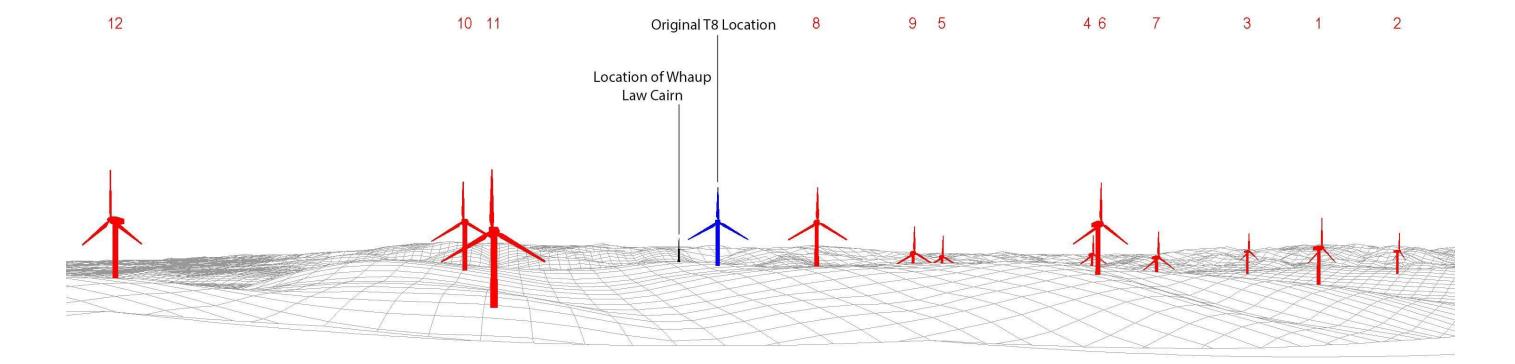
Figure A3: SM2738 Whether Law Cairn Comparison (120 degree field of view)

SM2738 Wether Law Cairn

Figure A3: SM2738 Whether Law Cairn T8 Comparison (120 degree field of view)

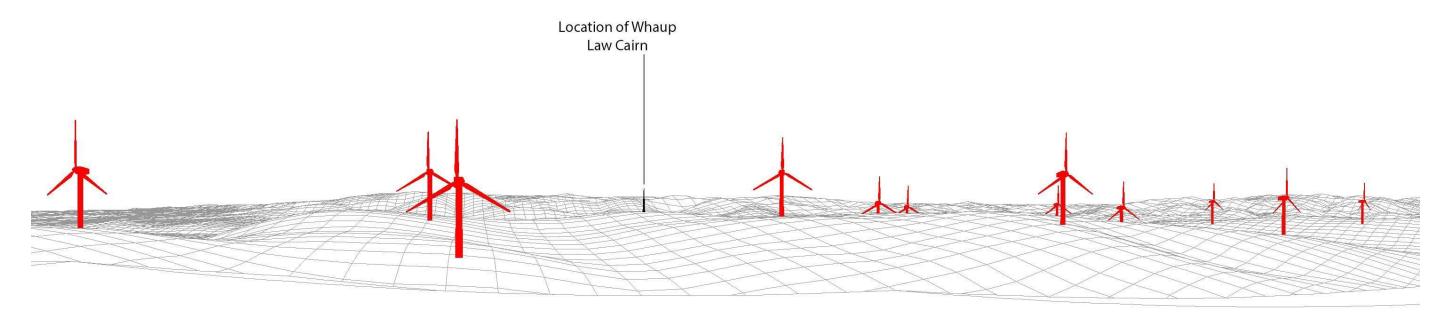
Figure A4: SM2738 Whether Law Cairn Relocation (120 degree field of view)

SM2738 Wether Law Cairn

Figure A4: SM2738 Whether Law Cairn T8 Relocation (120 degree field of view)

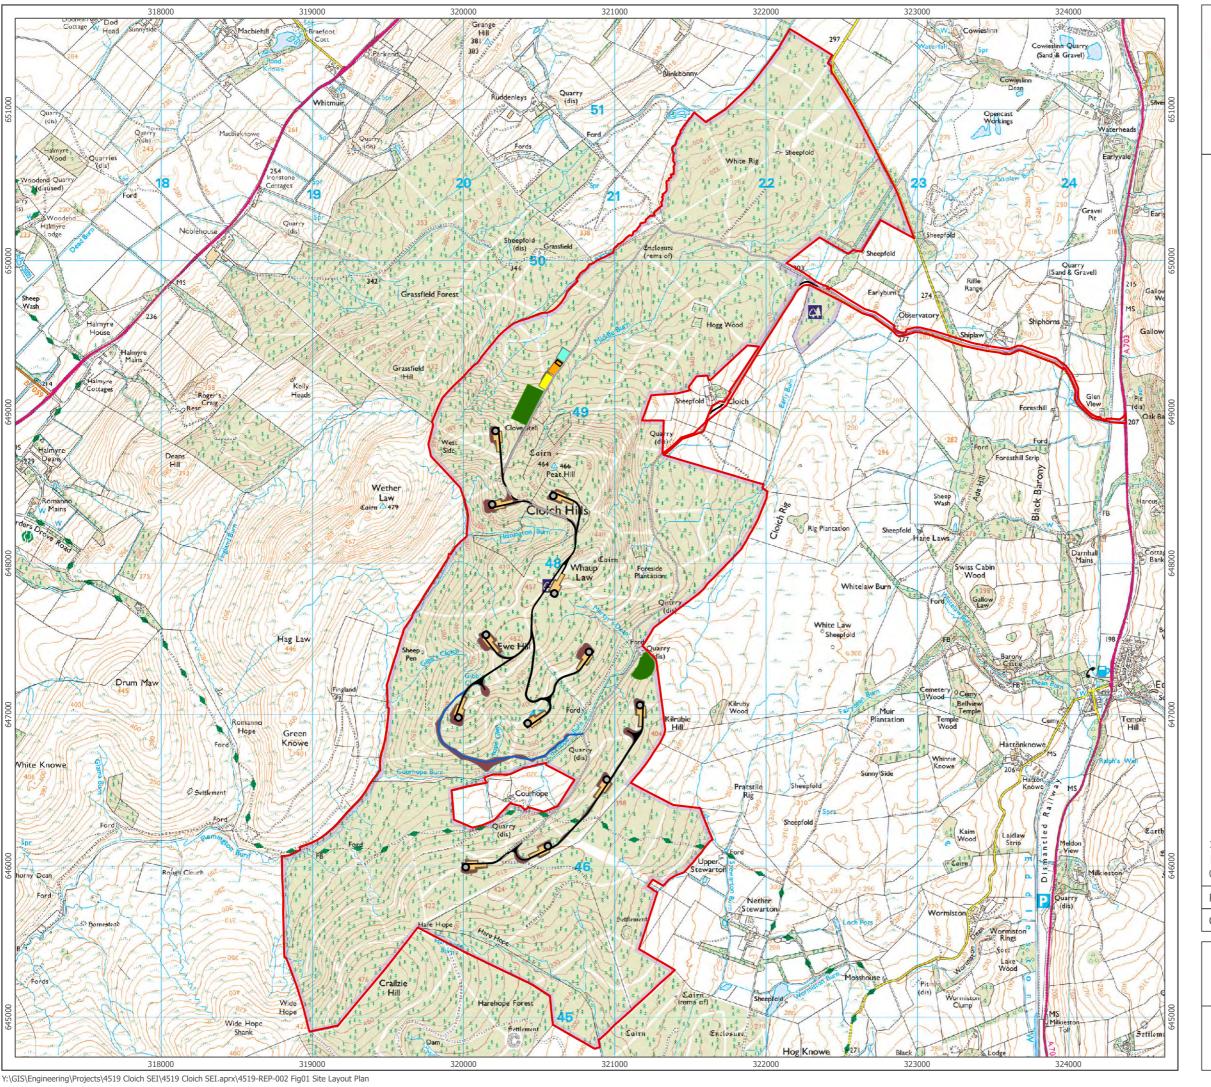
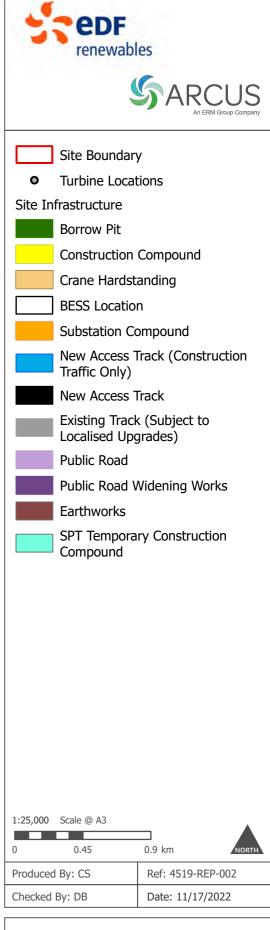
Figure 9.1.1

Site Layout Plan

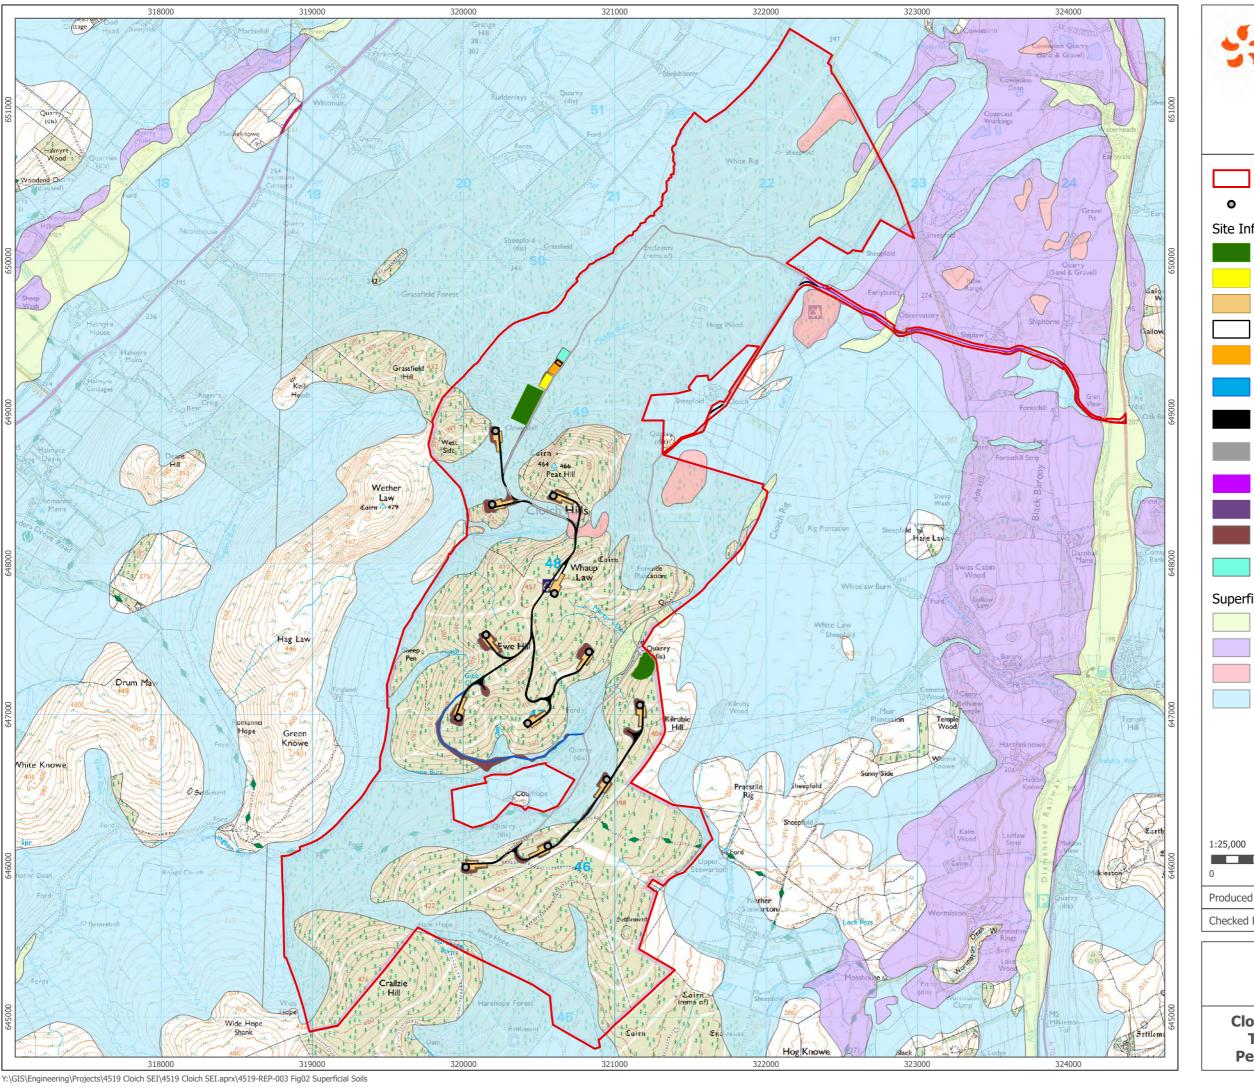
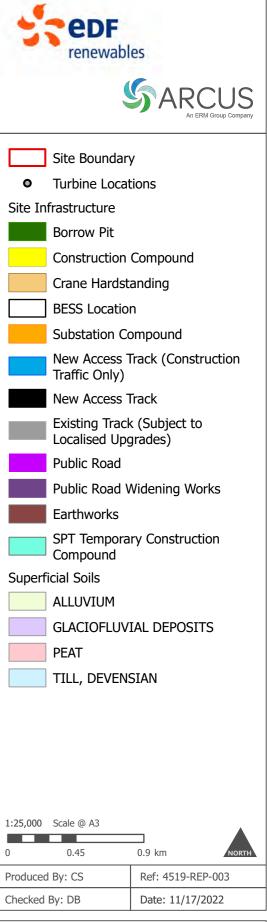
Figure 9.1.2

Superficial Soils

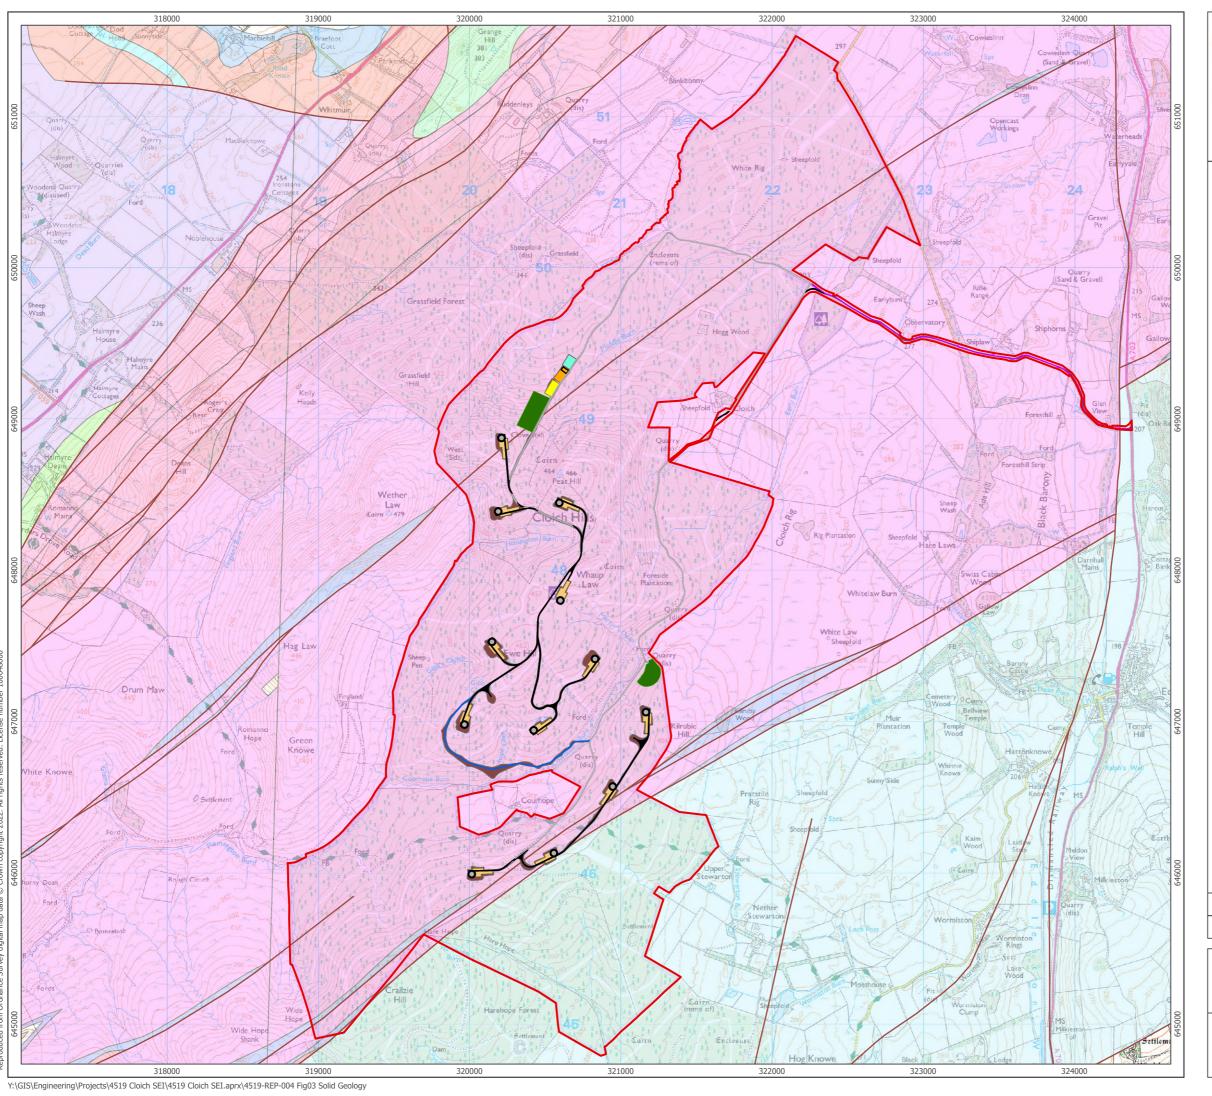
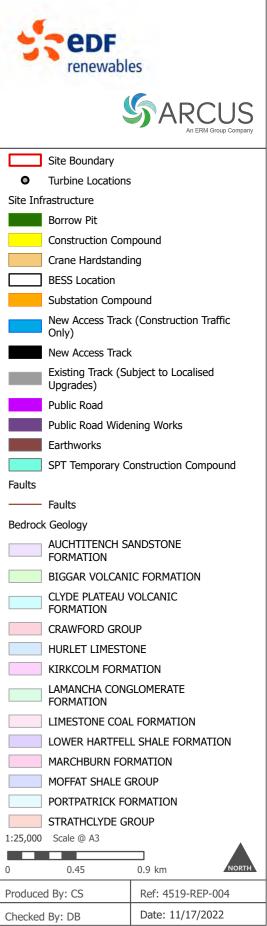
Figure 9.1.3

Solid Geology

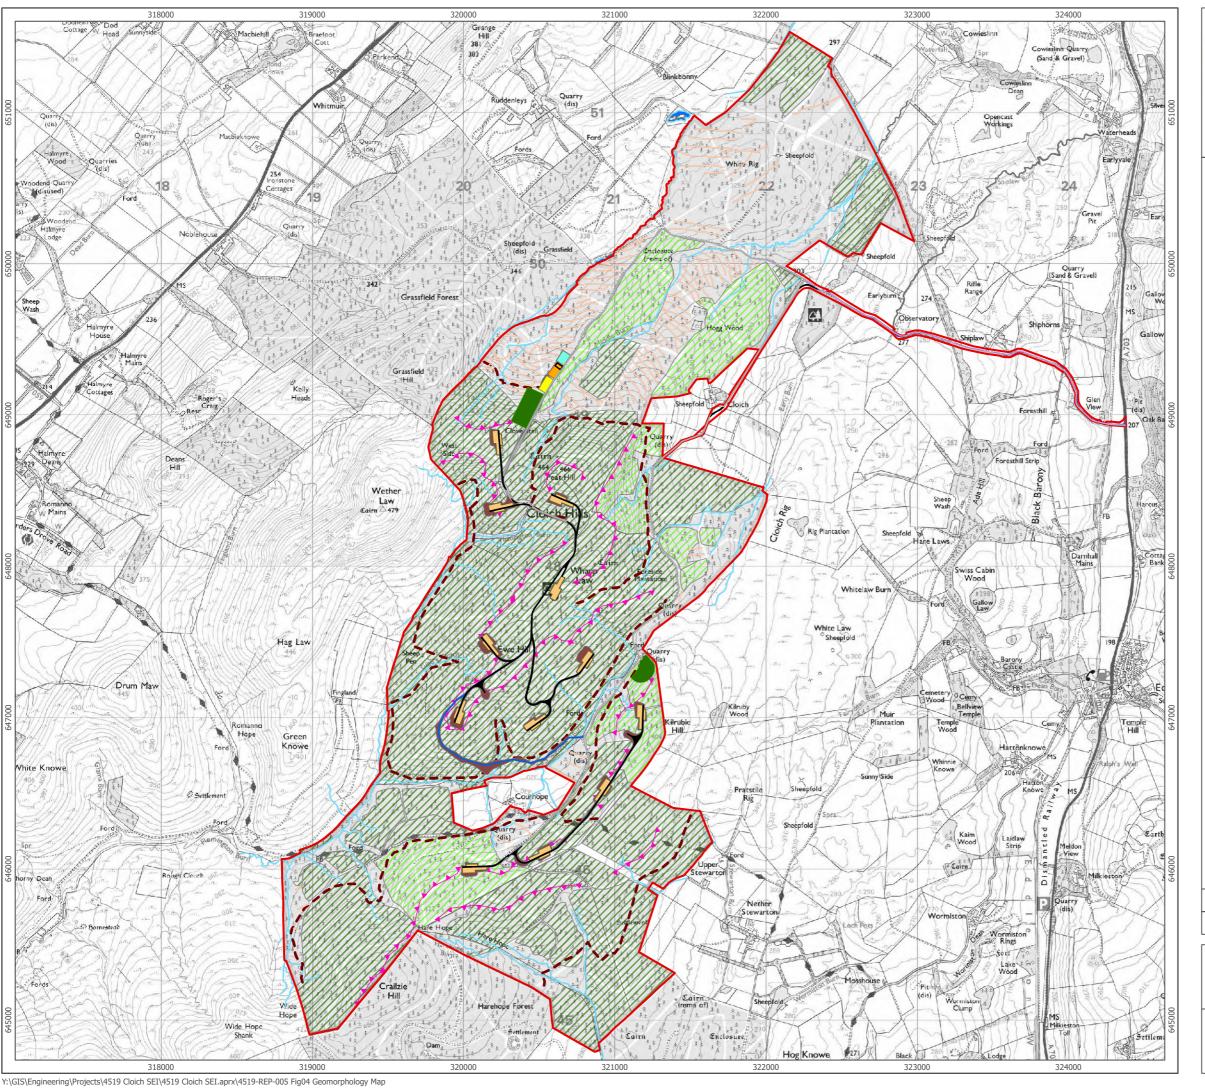
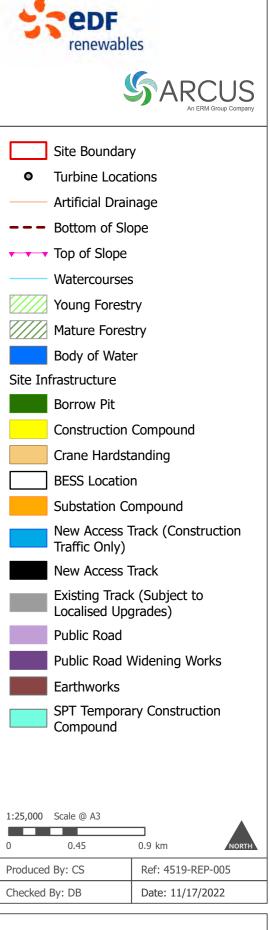
Geomorphology Map Figure 9.1.4

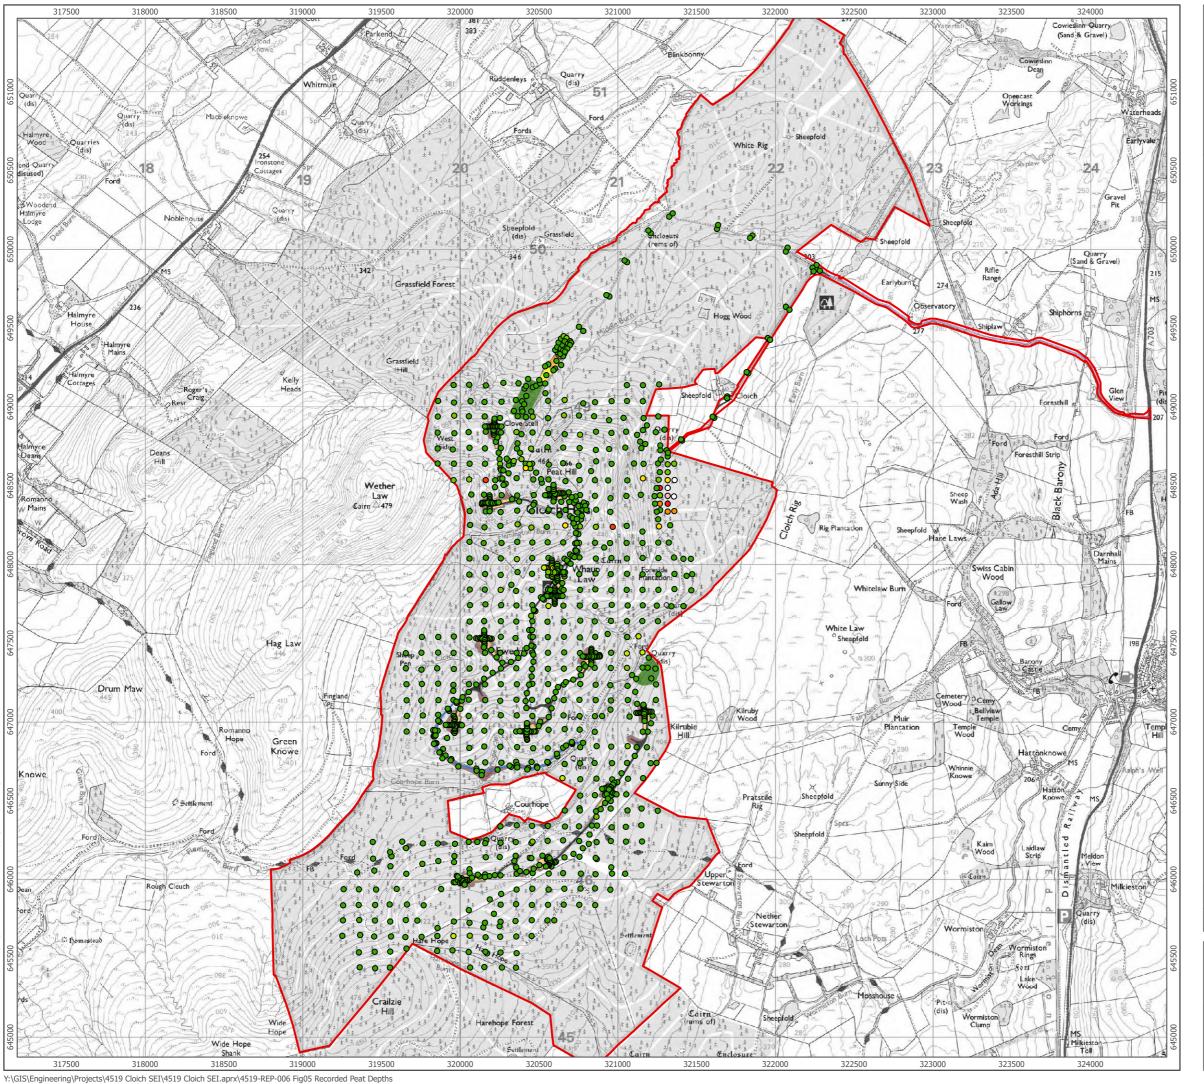
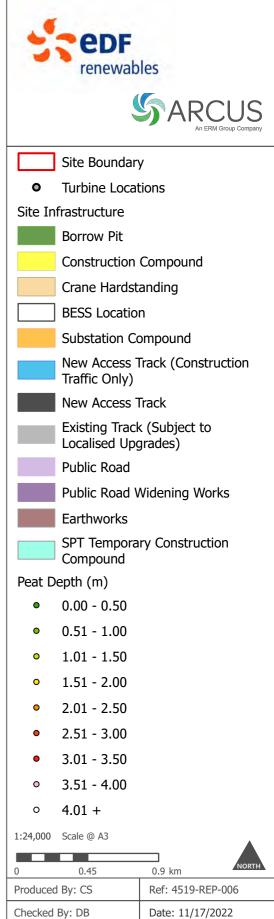
Recorded Peat Depths Figure 9.1.5

The maximum peat depth recorded was 4.6 m in the eastern sector of the Site, this was the only peat of this extent found in the entire Site.

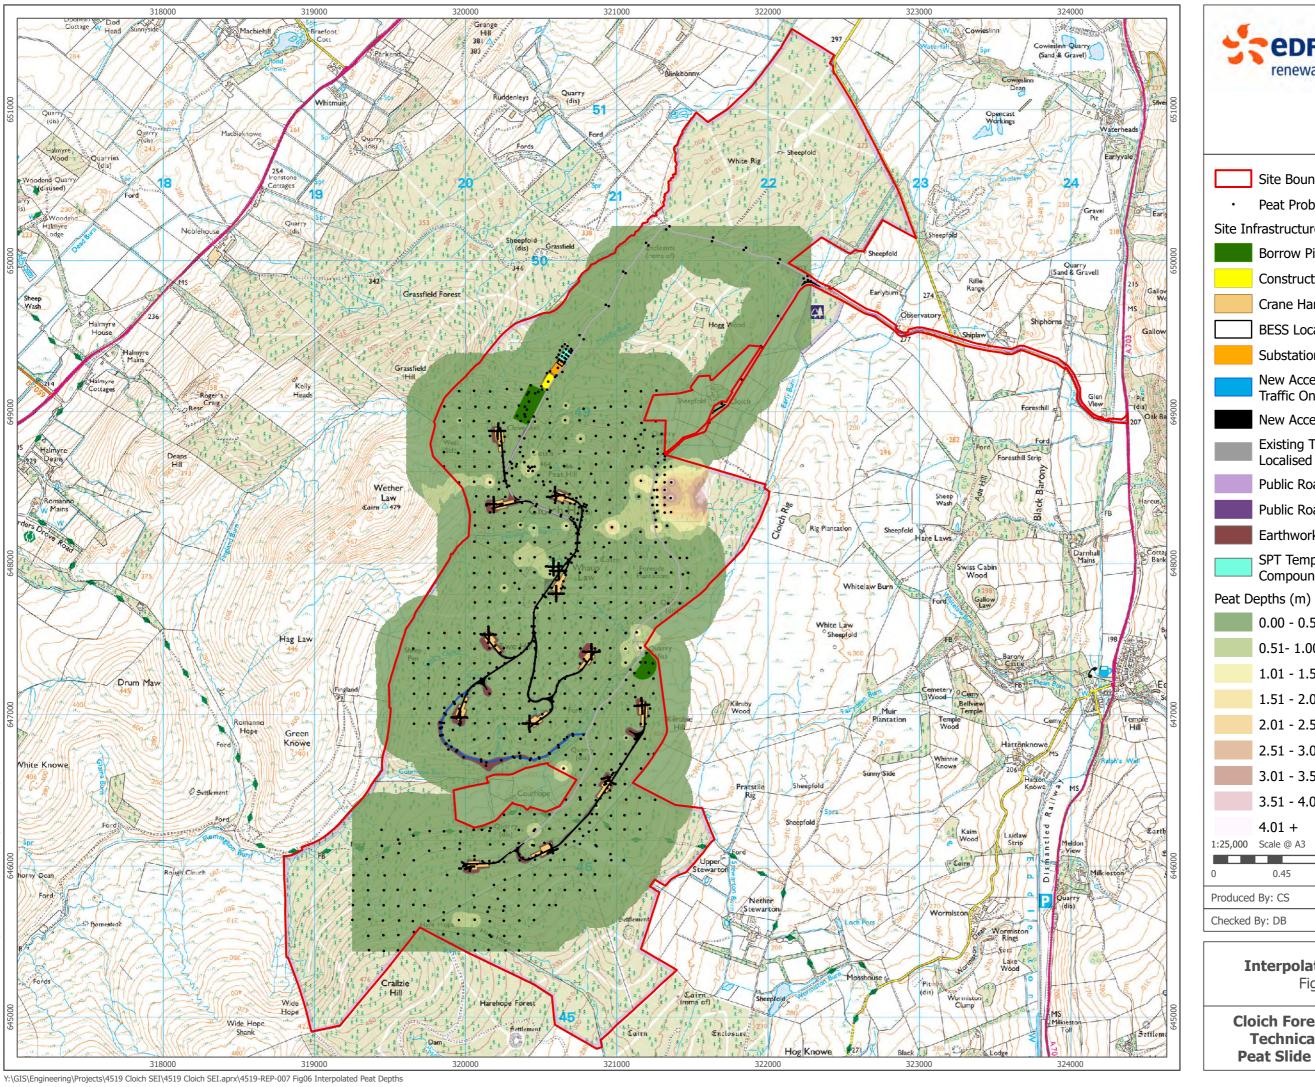
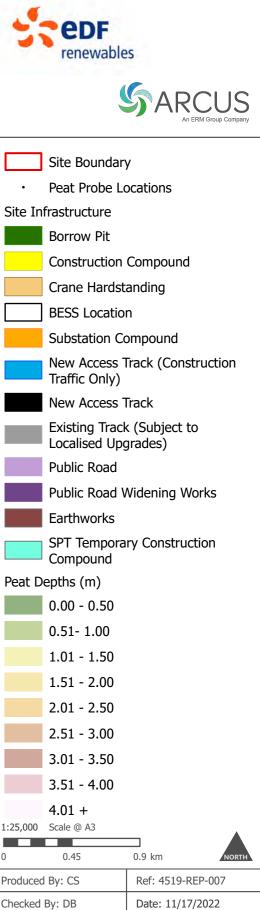
Interpolated Peat DepthsFigure 9.1.6

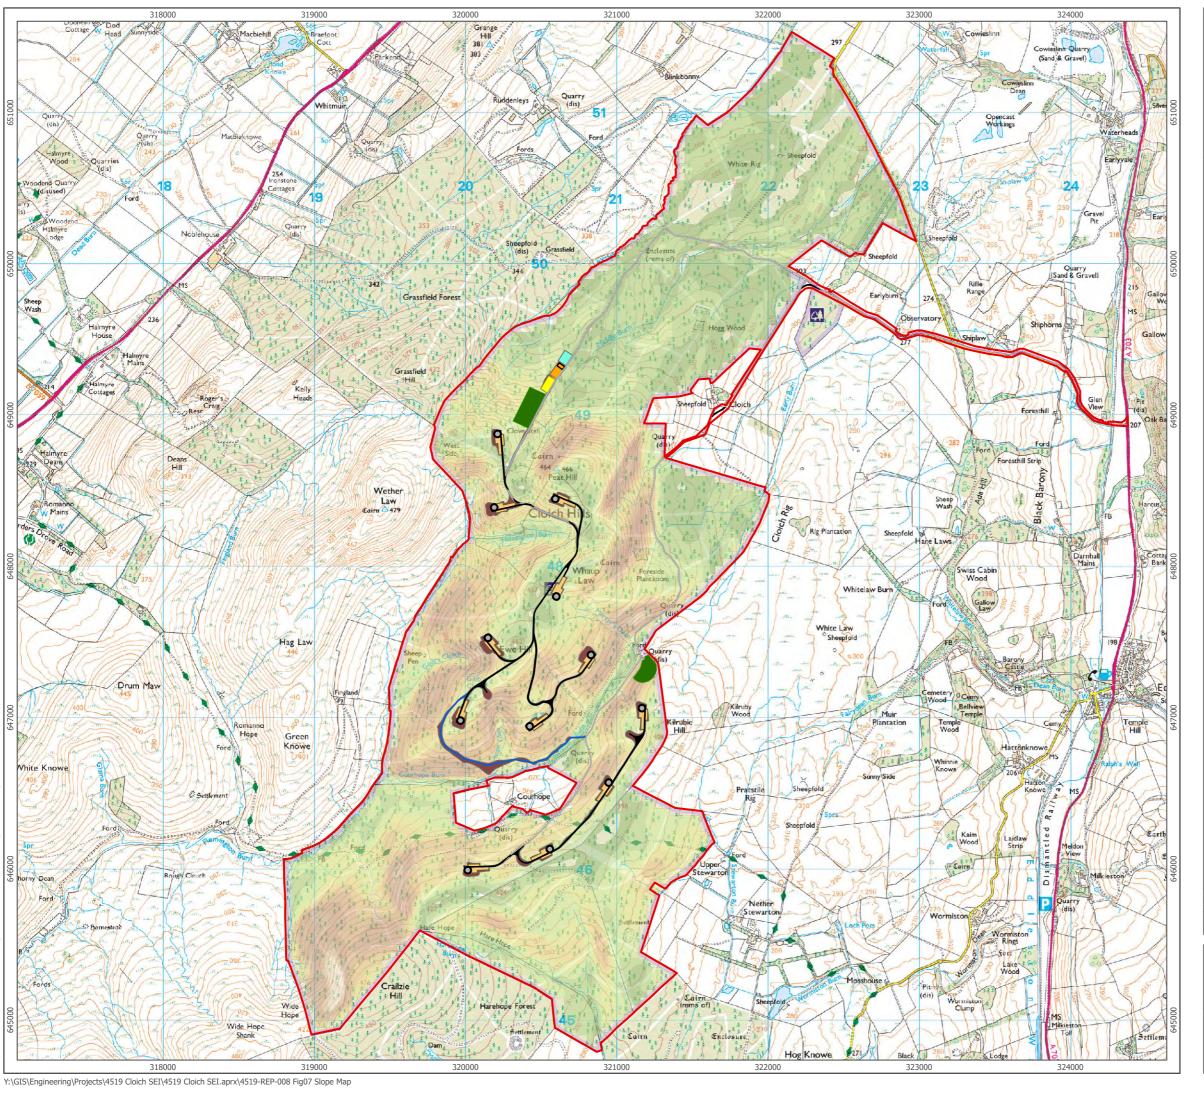
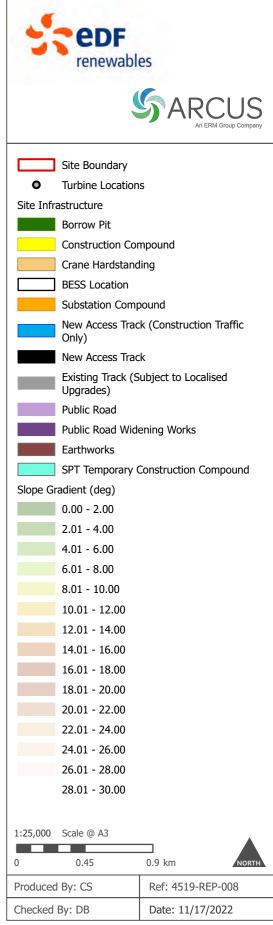
Slope Gradient

Of these, peat depth and slope gradient are considered to be principal factors. Without a sufficient peat depth and a prevailing slope, peat slide hazard would be negligible. The Slope Gradient is illustrated on Figure 9.1.7 for the Development (see Appendix A), the substrate material is also considered a key relevant factor in relation to the mechanics of slide, whilst the other aspects provide key considerations. The slope data is derived from Ordnance Survey 5m Digital Terrain Model (OS 5m DTM). It should be noted that historical peat probing at the Site did not include an estimate of the underlying substrate material, therefore a value of 2 (unknown) was assigned to these probing points which is equivalent to clay as seen in Table 5.1. This is considered a conservative figure which could increase the hazard ranking and is another layer of safety embedded within this PSRA.

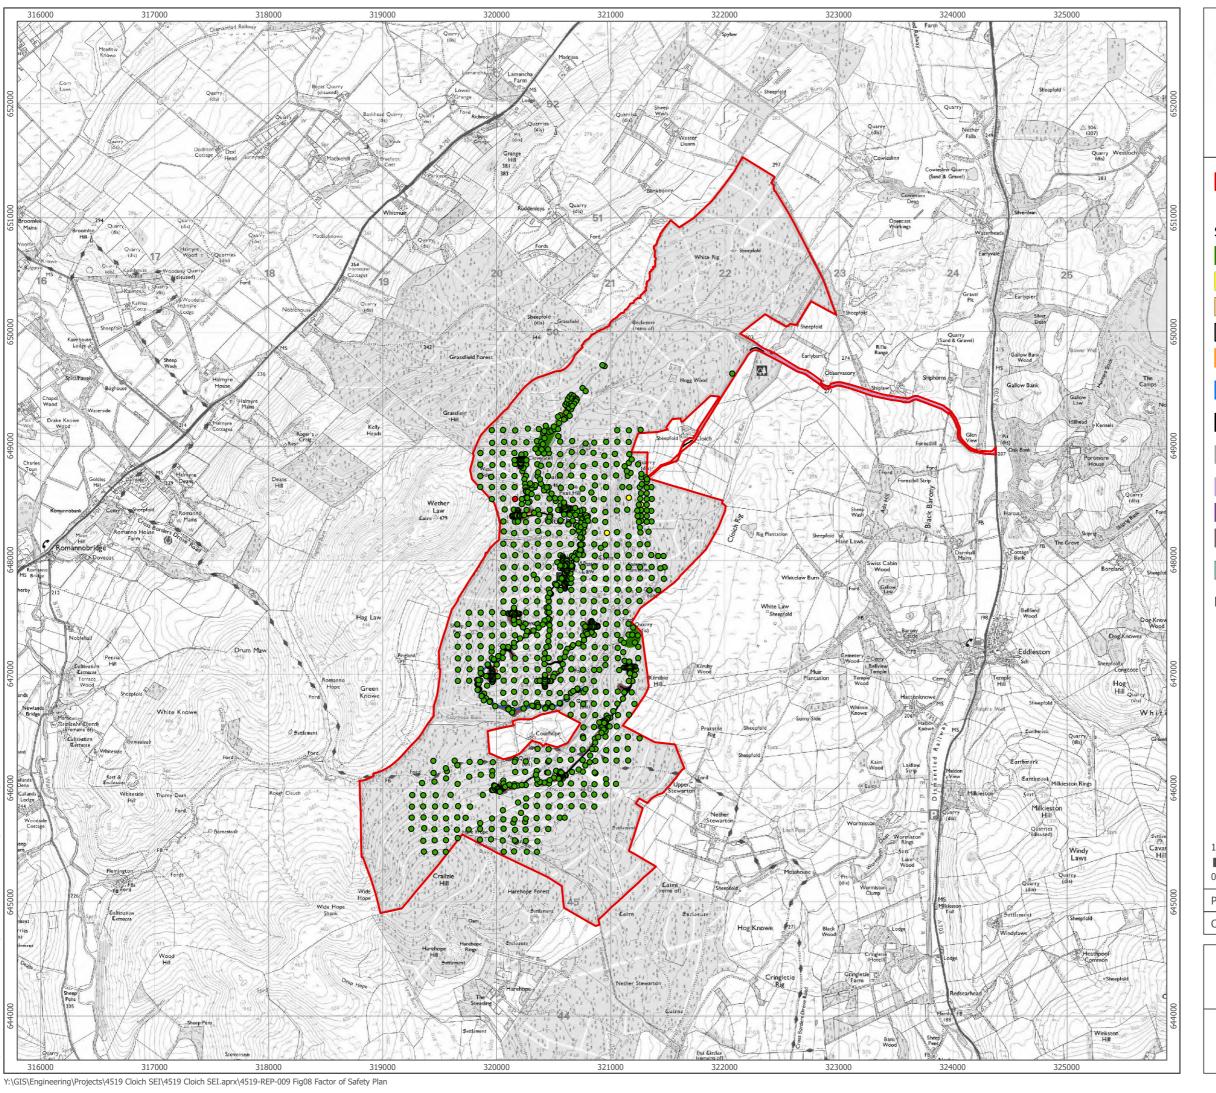
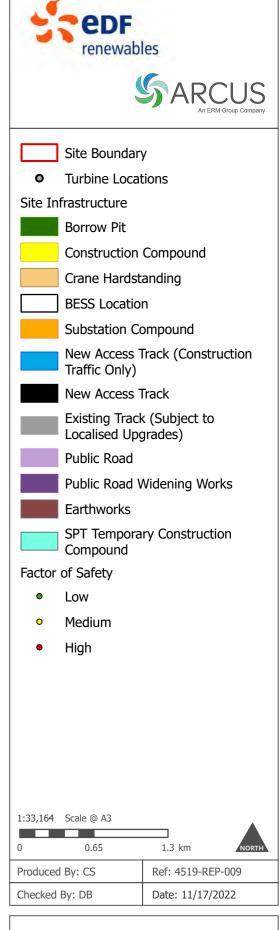
Factor of Safety Plan Figure 9.1.8

In accordance with the best practice method, F values of <1.0 indicate slopes that would experience failure under the modelled conditions and as such are considered areas of high risk. However, Boylan et al (2008) indicate that a relatively high value of F=1.4 should be used to identify slopes with the potential for instability. Adopting this approach, high risk areas area indicated where F is <1.0, medium risk areas are indicated as 1.01 to 1.50 and >1.5 are low risk.

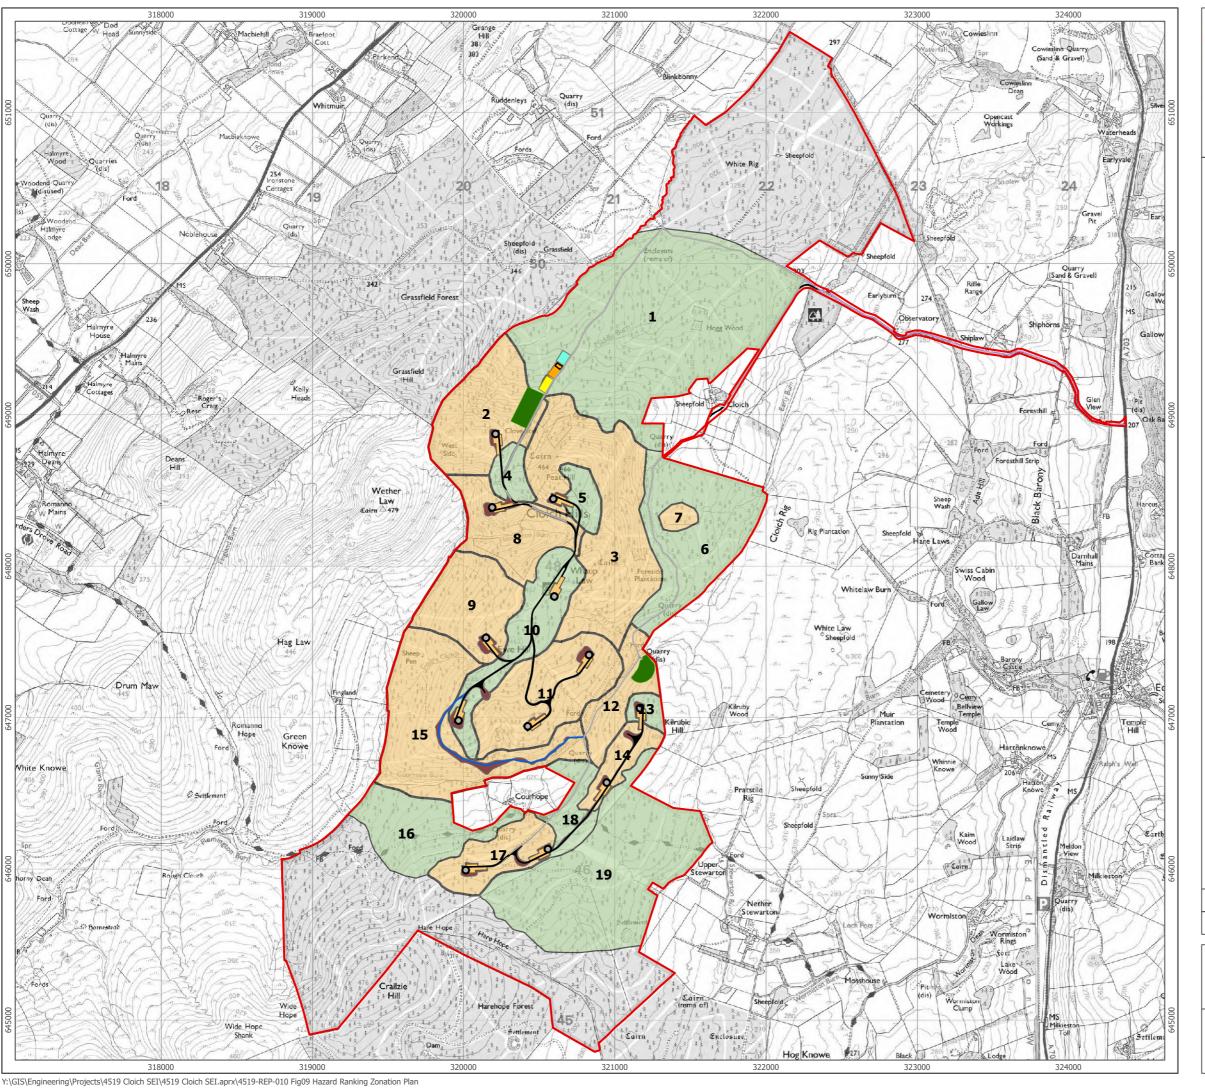
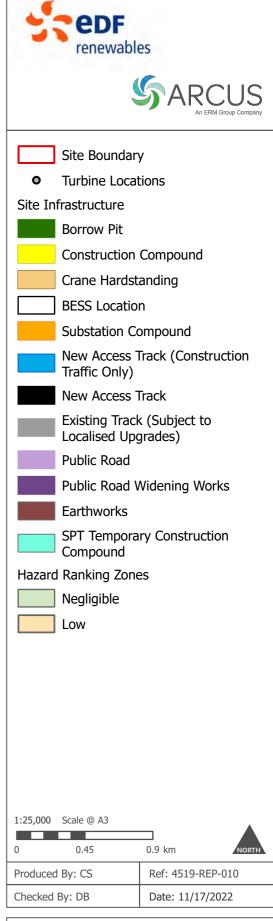
Hazard Ranking Zonation Plan

Receptor exposure was assessed for each of the hazard zones using the approach in Section 5. A summary of the Hazard Ranking result for each identified area is summarised in Table 7.1 and is presented in Figure 9.1.9 - Hazard Ranking Zonation Plan (see Appendix A). The zonation is based on a combination of considerations including calculated hazard result, peat depth, topography and receptors and land uses.

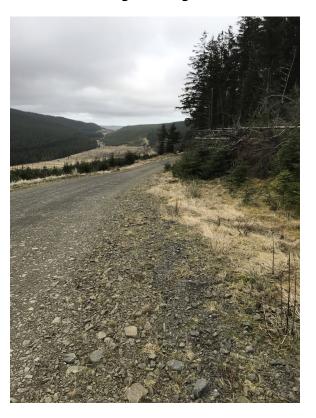
Photograph 1 - View North along existing track in the Southern Site area

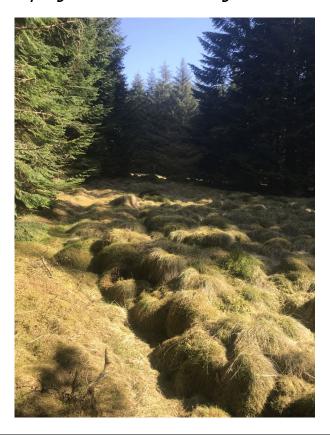
Photograph 2 – Sphagnum mosses in clearing within the central Site area

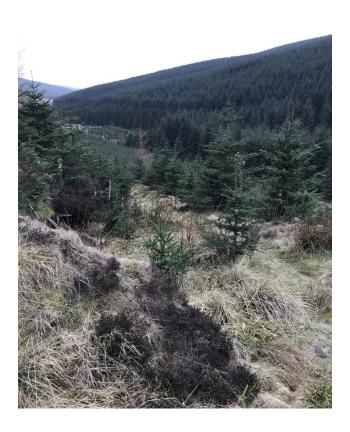
Photograph 3 – View Southeast from the central Eastern Site area

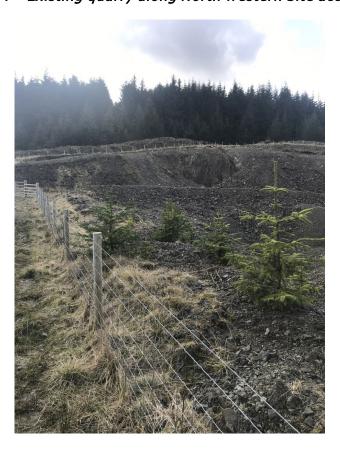
Photograph 4 – Existing quarry along North western Site access

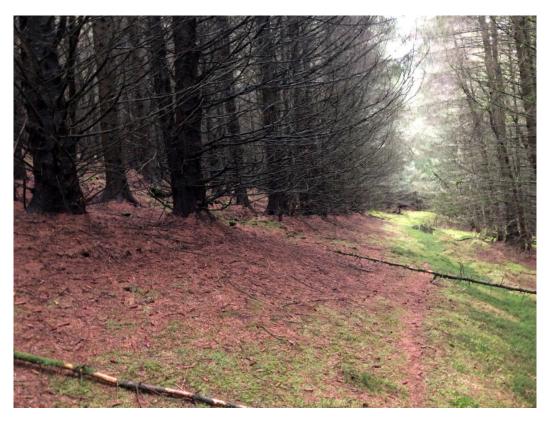
Photograph 5 – Fire break within plantation in the western Site area

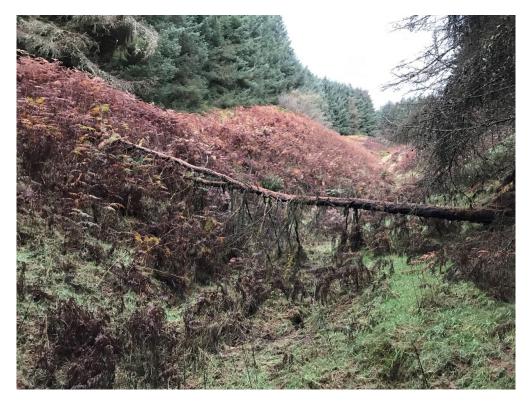
Photograph 7 – View North from central area of the Site

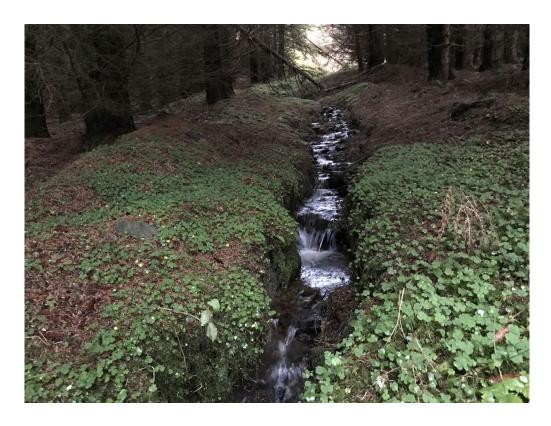
Photograph 8 – Watercourse running through plantation in the central Western Site area

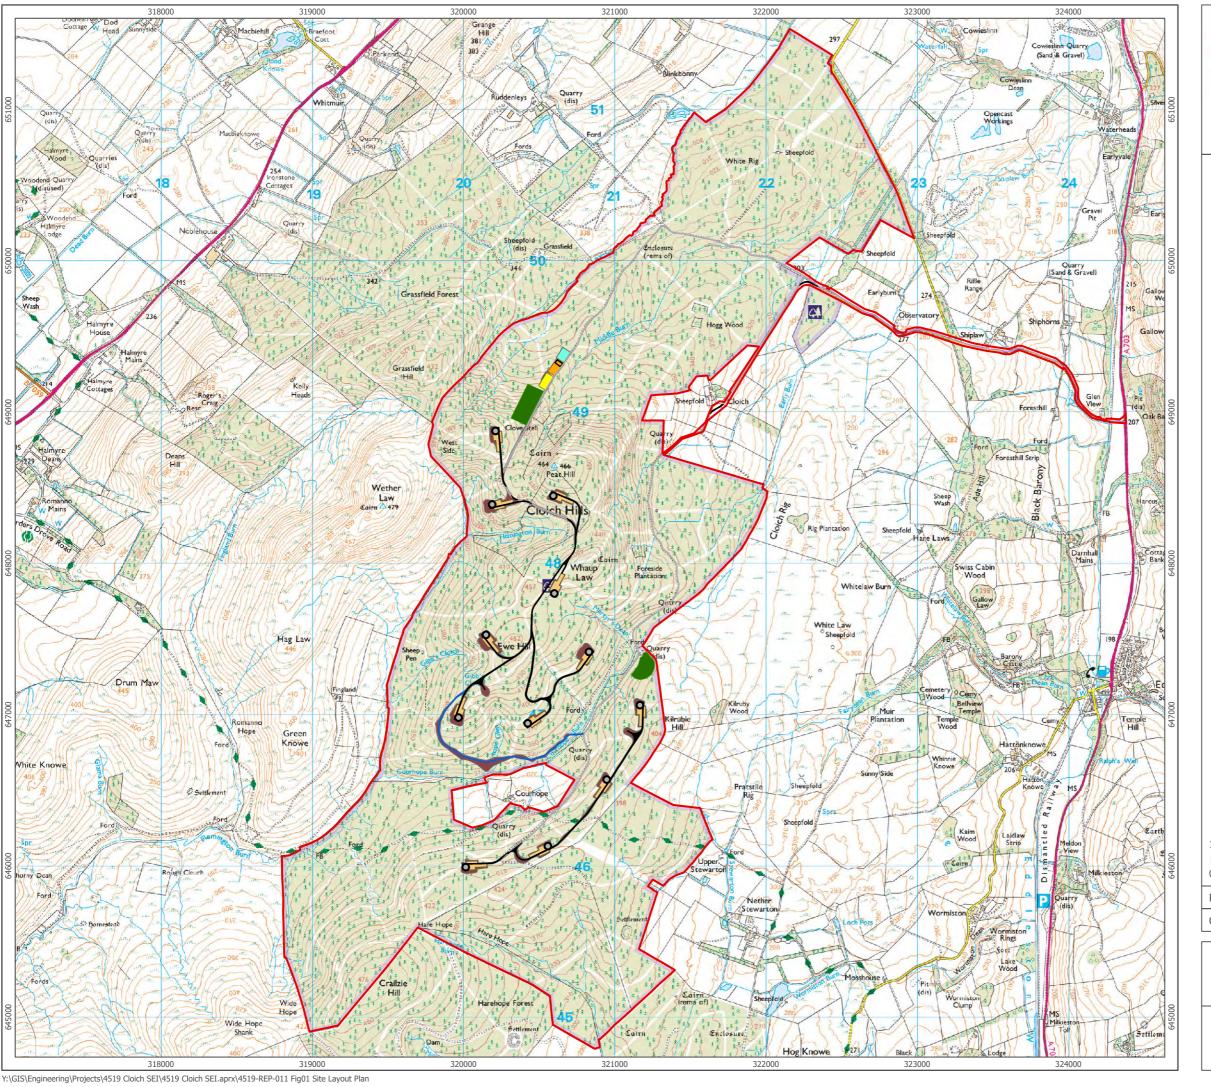
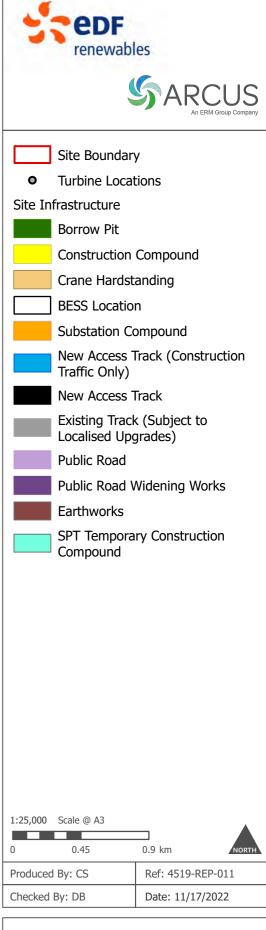
Site Layout Plan Figure 9.2.1

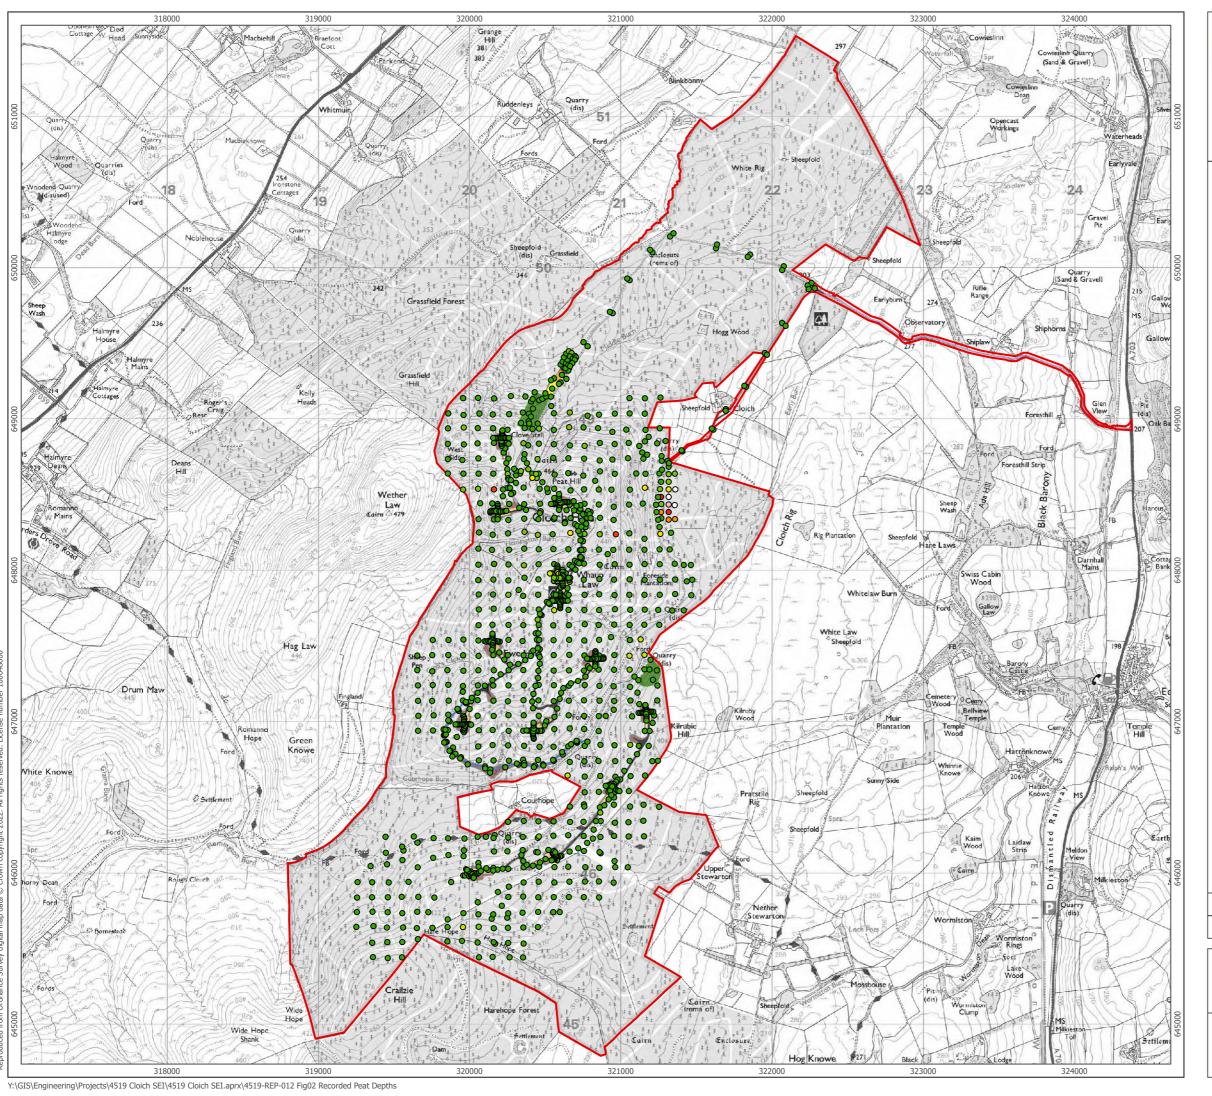
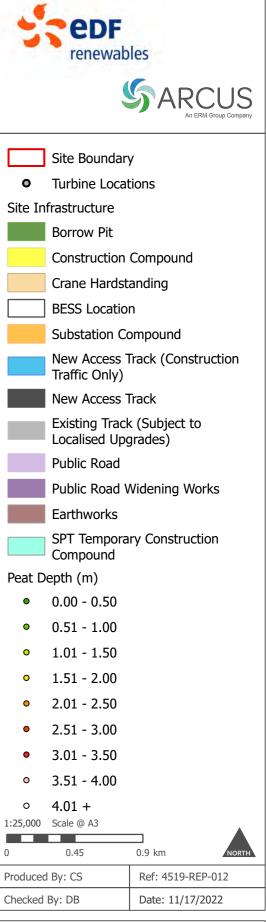
Recorded Peat DepthsFigure 9.2.2
