Cloich Forest Wind Farm

Volume 3 – SEI Report Technical Appendices (Part 1 of 2)

A9.1 Peat Slide Risk Assessment

TECHNICAL APPENDIX A9.1: PEAT SLIDE RISK ASSESSMENT

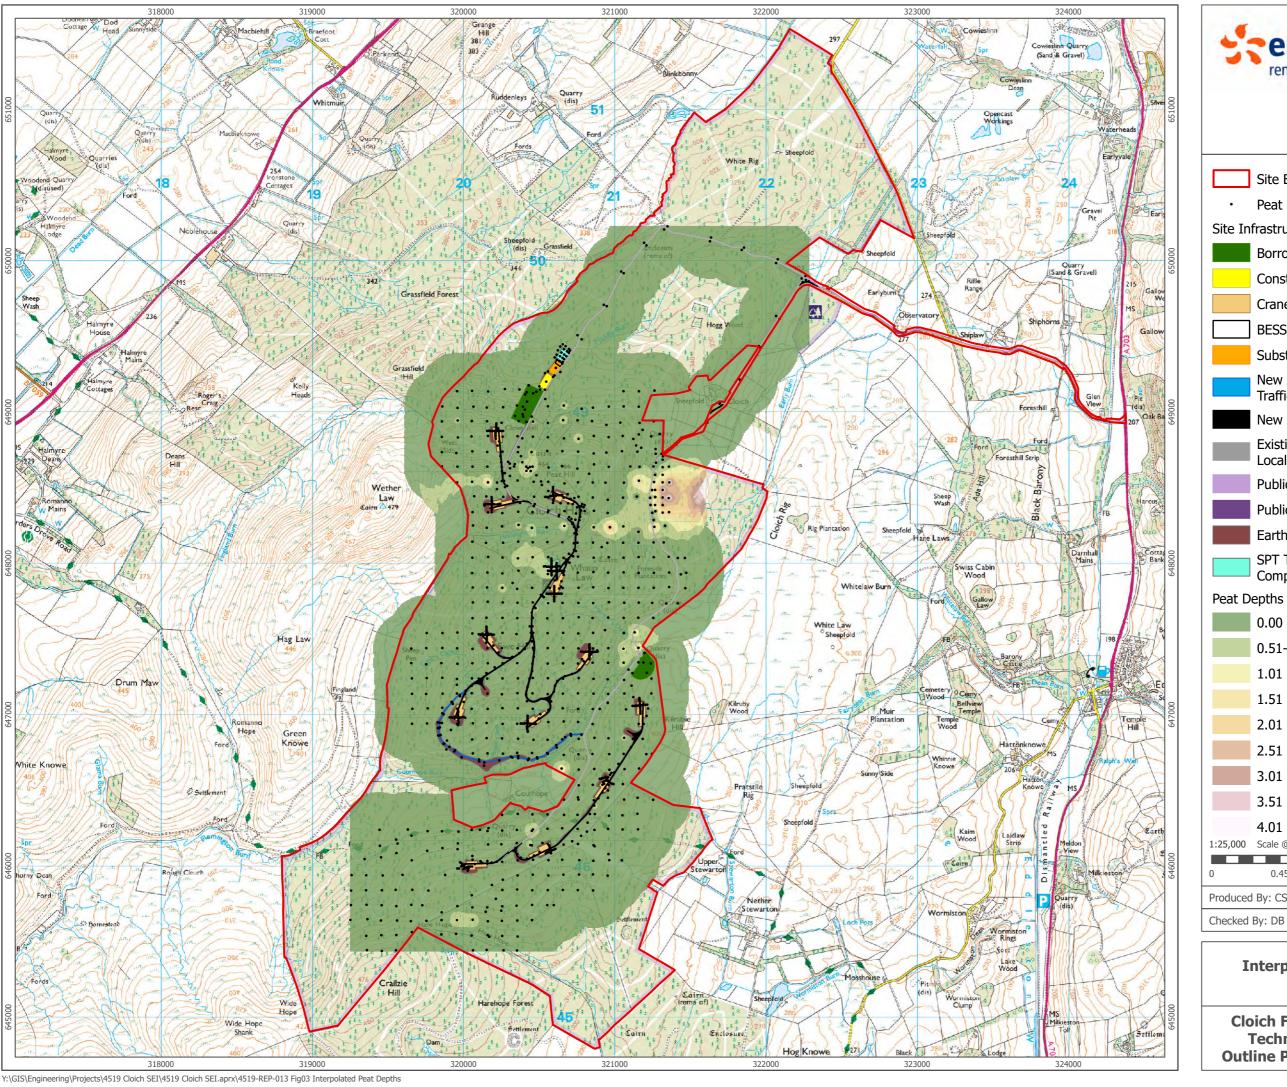
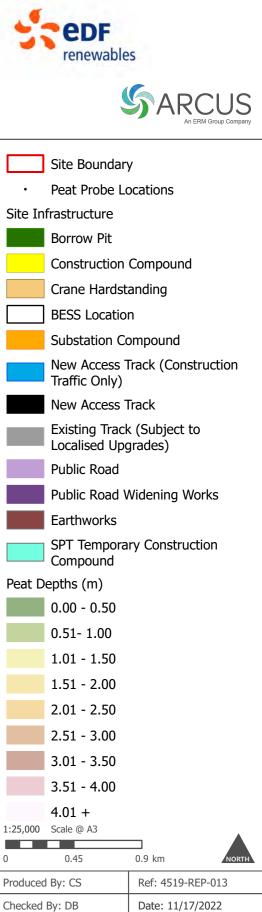
Interpolated Peat DepthsFigure 9.2.3
